Subject: Report of Engineering Consulting Services
MILESTONE INSPECTION – PHASE I SUMMARY LETTER
Sea Castle Condominium
4939 Floramar Terrace
New Port Richey, Pasco County, FL 34652
SOCOTEC Project Number VS234766

MILESTONE INSPECTION – PHASE I REPORT

The Castle Council, Inc.
4939 Floramar Terrace
New Port Richey, Pasco County, FL 34652

SOCOTEC Project Number VS234766

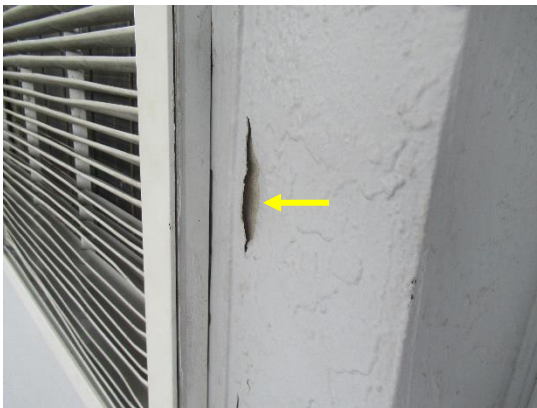
View of typical delaminated paint.

- A few areas of distressed stucco throughout the structure.
- Delaminated exterior paint.
- Delaminated concrete on the breezeways.

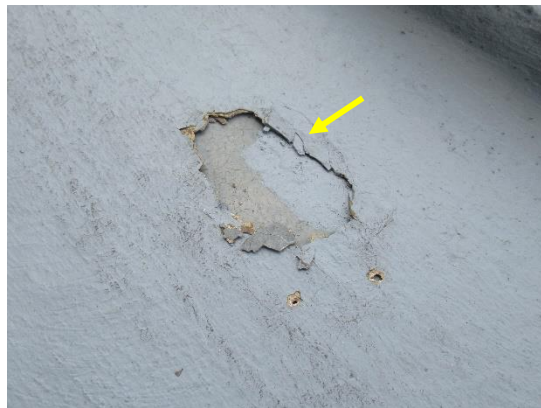
View of deteriorated coating on the breezeways.

- Rust staining under the stairs.
- Distressed coating on the breezeways.
- Possible water intrusion in a few units.

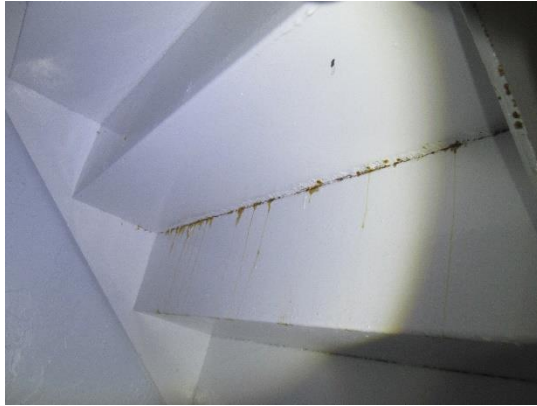
View of typical rust staining under stairs.

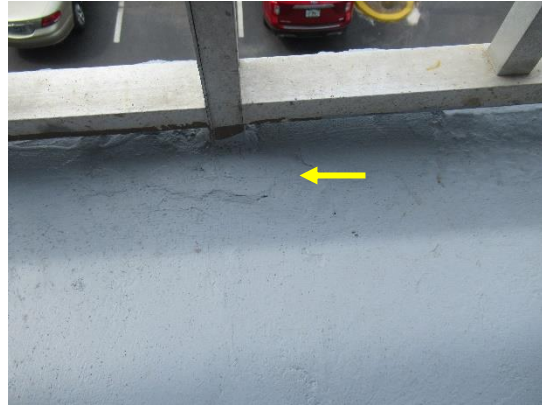
View of delaminated concrete on breezeway.

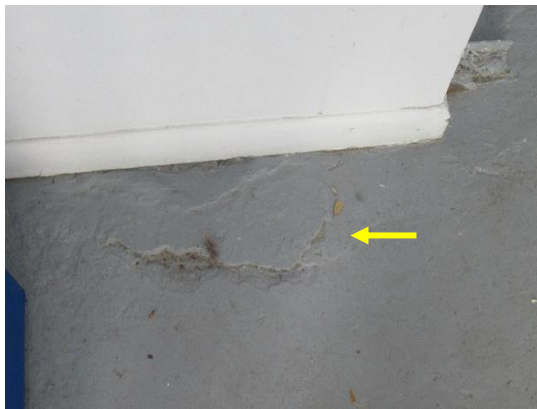
View of delaminated concrete in the laundry room.

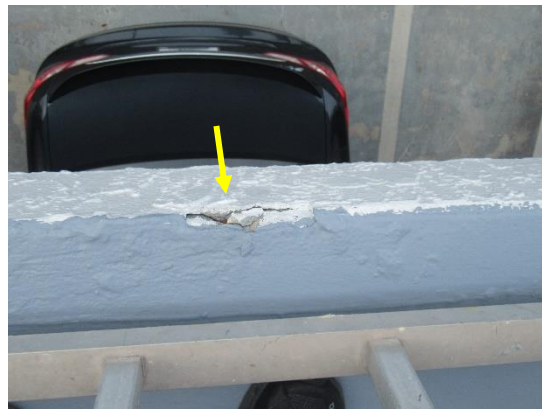
View of delaminated stucco on the breezeway edge.

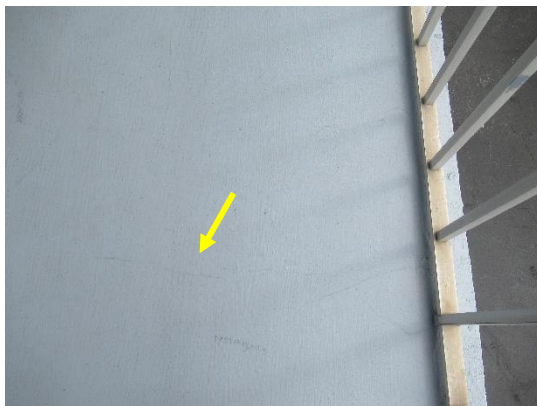
View of typical breezeway crack.
