Structural Integrity Reserve Study Report

Sea Castle Condominium

4939 Floramar Terrace, New Port Richey, FL, 34652 For Period Beginning January 1, 2025

SOCOTEC Consulting, Inc

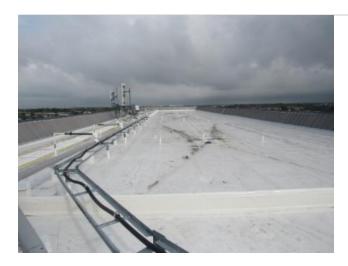
1 - Flat Roof

<u>Flat Roof</u> - The flat roof of the building consists of a single-ply membrane. This type of roof system typically has a useful life of 20 to 25 years under normal operating conditions with routine yearly maintenance. We understand the roof was replaced at the beginning of 2024. At the time of our site visit, the single-ply roof system was observed to be in overall good condition. We have included a reserve item for replacement of the flat roof.

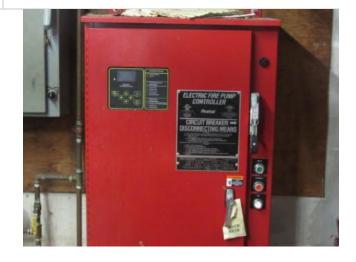
Fire Pump and Controller - The 40 hp electric fire pump and controls are located in the mechanical room on the first floor. Over time, replacement parts may not be available. Therefore, the Association may need to replace the entire pump assembly in the future. These types of systems generally have a useful life of 40- to 50-years under routine maintenance. We understand the fire pump assembly was last replaced in 1989. We have included a reserve for replacement/repairs to the system as needed.

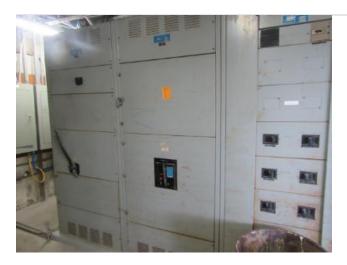
<u>Electrical System</u> - The main electrical equipment (switches, breakers, and panels) is in the electrical room on ground level. Localized breaker panels are within units. Localized breaker panels and branch circuits are typically replaced during common area or individual unit renovations as required to accommodate the renovation. A reserve has been included for periodic replacement/upgrades of major electrical system components such as main service panels and feeder lines.

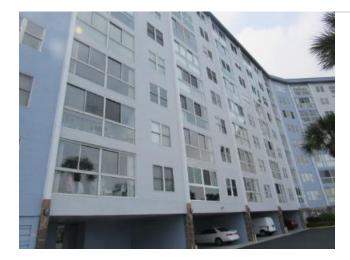
Exterior Painting and Restoration - We understand the Association completed an exterior painting and restoration project in 2024. Buildings located in the southwest Florida region are recommended to have their exteriors recoated on a 7 to 10-year basis. A reserve has been included for periodic recoating and restoration of the building exterior on an 10-year cycle.

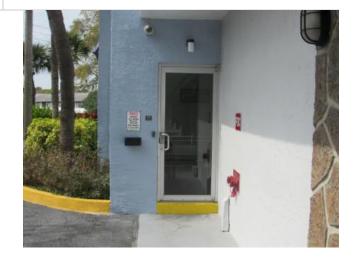
Common Area Exterior Doors - We understand the Association is responsible for all common area exterior doors in the structures. It is our understanding that the common area doors were are replaced on an as needed basis. Typically, doors of this type have a useful life of approximately 30 years. Replacement of the doors should vary based on routine maintenance, exposure, and wear and tear. We have included a reserve allowance for replacing the doors on an as needed basis.
